Manhole Inspection Summary

Manhole # S13AA1018MH

Insp Date: **1/26/09 10:34 AM**

Location Address: **3003 SPRINGHILL AVE** Cross Street: **TOWANDA AVE**

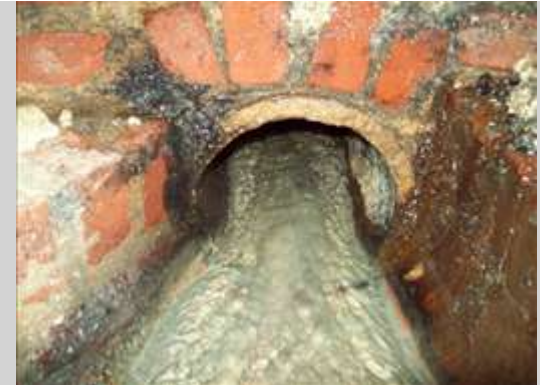
12 O'Clock Outflow

8 in. Circular Gravity Sewer
Pipe Out @ 12 O'Clock

Pipe Height: (in.) Direct
Pipe Material: **Clay** ☐ Pipe Lined
Invert Depth: **24.14** (ft.) Flow Characteristics: **Fast**
Deposits: ☒ None ☐ Mud ☐ Sludge ☐ **Debris** ☐ Grease
Silt Depth: (in.) Deposits Extent:
Infiltration: **None** Pipe Seal Cond: **Sound**

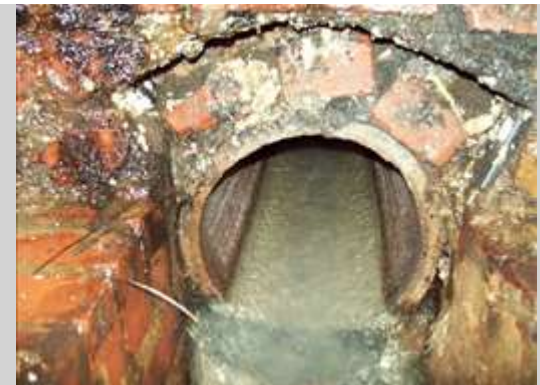
6 O'Clock Inflow

8 in. Circular Gravity Sewer
Pipe In @ 6 O'Clock

Pipe Height: (in.) Direct
Pipe Material: **Clay** ☐ Pipe Lined
Invert Depth: **17.06** (ft.) Flow Characteristics: **Fast**
Deposits: ☒ None ☐ Mud ☐ Sludge ☐ **Debris** ☐ Grease
Silt Depth: (in.) Deposits Extent:
Infiltration: **None** Pipe Seal Cond: **Sound**

Drop: **Outside Direct**
Angled: Reading: (ft.)
Inv Depth: **23.82** (ft.)
Drop Condition: **Partly Clogged**
